**Flood Control Project Maintenance
Levee Inspections**
LMA District Cover Sheet
Spring 2020 Levee Inspection Results

Lower San Joaquin Levee District

Spring 2020 Levee Inspection Results

Waterway			Bank	Unit Miles
Unit No. 01 San Joaquin River			Right	22.52
	Spring (March - May)	Summer (June - August)	(September - November) Fall	Winter (December - February)
Unit Maintenance Rating (Fall Only)				
Date of Inspection	4/21/2020 - 4/21/2020			
DWR Inspector	Corey Fujitani			
Accompanied By

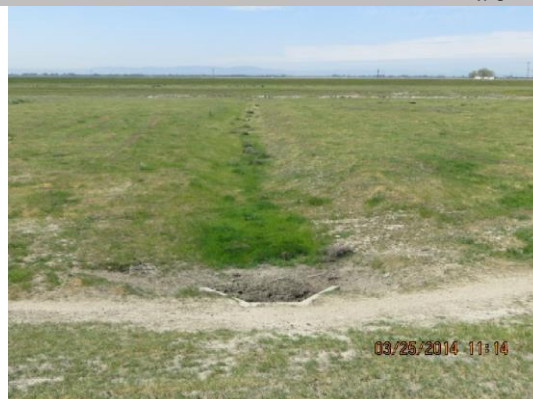
Photo 1 of 3 : UCIP_SP_2020_39625_59316.jpg

DS_ID:19804
FS_ID:39625
EP_NO: N/A
Repair Type: Non-Urgent
Crossing Status: Found
UCIP Comments: 03/25/2014 Dense vegetation limits the inspector's visibility to identify signs of pipe failure (leaks) along the landward slope. Recommend removing vegetation along pipe alignment to conduct proper inspection of structure. Sediment buildup in pipe visible from landward side--recommend contacting owner to clear pipe. (DWR UCIP - W. Wylie)
FIELD_STRUCT_DESC: 30-inch corrugated metal gravity drainage pipe through the levee, 12 feet below the crown. Flap gate on the waterside (WS) end. Concrete headwall on the landside (LS) end. Concrete U-shaped headwall on the WS end. [Additional Reference(s): DWR Levee Log, 2002. USACE San Joaquin O&M Manual 601.1, 1967, (HLM 25.51)].
FS Date: 3/25/2014

Concrete headwall on WS toe.

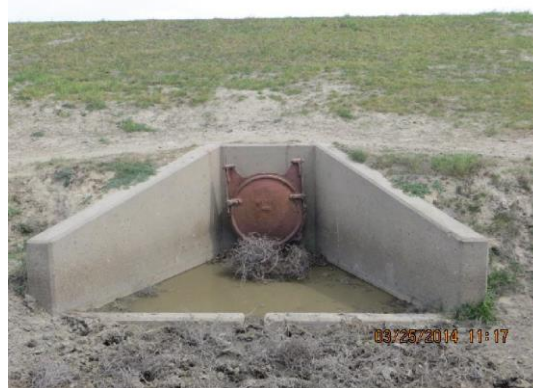
Photo 2 of 3 : UCIP_SP_2020_39625_59317.jpg

Flapgate on concrete headwall at WS toe.

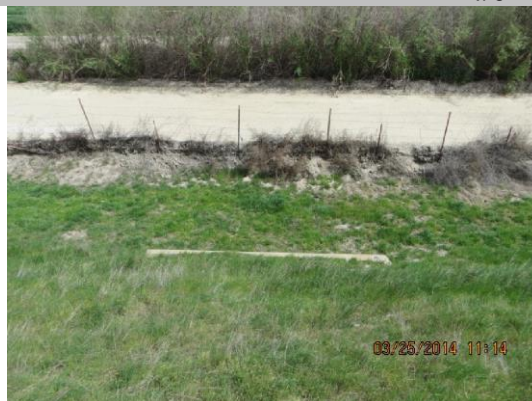
Photo 3 of 3 : UCIP_SP_2020_39625_59315.jpg

Concrete headwall on LS toe.

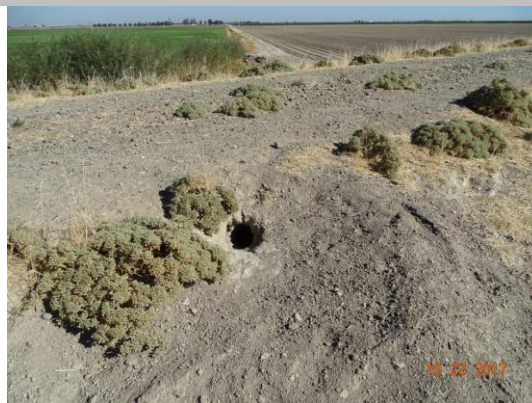
Photo 1 of 1 : SP_2020_NA0010_123_124_20200225_00030.jpg

Looking east at the waterside slope.

LM Start	25.61	Rating **	M	Issue No.	124
LM End	25.61	Issue Type +	Ma	Location *	WS
Category	Earthen Levee			GPS Latitude/Longitude	
				Start	End
Item	Animal Control			37.047416 °	37.047416 °
				-120.488411 °	-120.488411 °
DWR ID	DWR_NA0010_05_f_2017_124				
Comment Code					
A1 : Exterminate rodents and backfill and compact or grout burrows.					
Inspector Comment

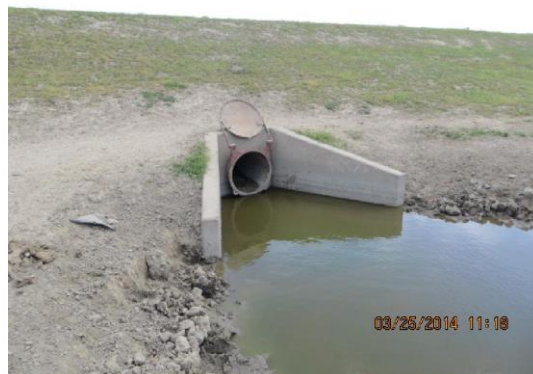
Photo 1 of 3 : UCIP_SP_2020_39626_59321.jpg

LM Start	25.63	Rating **	M	Issue No.	1381	
LM End	25.63	Issue Type +	Ma	Location *		
Category	Supplemental			GPS Latitude/Longitude		
				Start		End
Item	DWR UCIP LMA Responsibility			37.047170 °		37.047170 °
				-120.488222 °		-120.488222 °
DWR ID	19805					
Comment Code						
Inspector Comment						
DS_ID:19805 FS_ID:39626 EP_NO: N/A Repair Type: Non-Urgent Crossing Status: Found UCIP Comments: 03/25/2014 Sediment buildup in pipe visible from landward side--recommend contacting owner to clear pipe. (DWR UCIP - W. Wylie) FIELD_STRUCT_DESC: 30-inch corrugated metal gravity drainage pipe through the levee, 12.1 feet below the crown. Flap gate on the waterside (WS) end. Concrete headwall on the landside (LS) end. Concrete U-shaped headwall on the WS end. [Additional Reference(s): DWR Levee Log, 2002. USACE San Joaquin O&M Manual 601.1, 1967, (HLM 25.53)]. FS Date: 3/25/2014

Flapgate on headwall at WS toe.

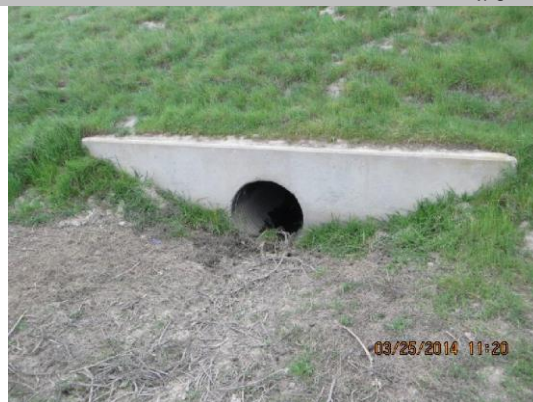
Photo 2 of 3 : UCIP_SP_2020_39626_59320.jpg

Concrete headwall on LS toe.

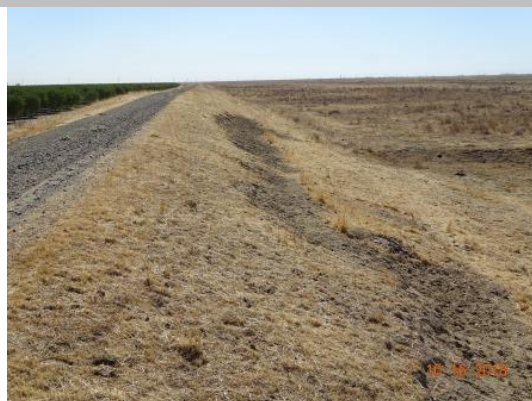
Photo 1 of 1 : SP_2020_NA0010_123_161_20200225_00057.jpg

LM Start	26.19	Rating **	M	Issue No.	161
LM End	26.21	Issue Type +	Ma	Location *	WS
Category	Earthen Levee			GPS Latitude/Longitude	
				Start	End
Item	Animal Control			37.040289 °	37.040043 °
				-120.482988 °	-120.482795 °
DWR ID	DWR_NA0010_05_f_2018_161				
Comment Code					
A2 : Repair the levee slope damaged by livestock and prevent large animal access.					
Inspector Comment					
Waterside slope damage is caused by livestock foot traffic.

Slope damage on waterside. (Fall 2018)

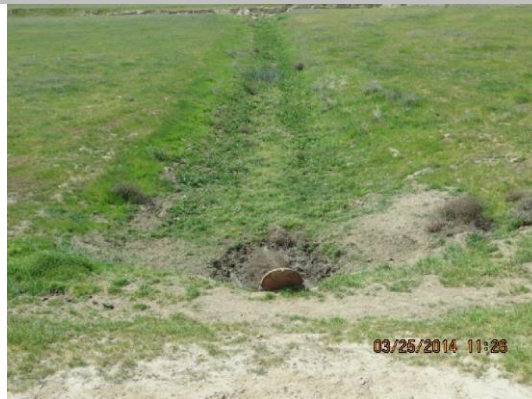
Photo 1 of 3 : UCIP_SP_2020_39627_59341.jpg

Comment Code						
Inspector Comment						
DS_ID:19806						
FS_ID:39627						
EP_NO: N/A						
Repair Type: Non-Urgent						
Crossing Status: Found						
UCIP Comments: 03/25/2014 Sediment buildup in pipe visible from landward side--recommend contacting owner to clear pipe. (DWR UCIP - W. Wylie)						
FIELD_STRUCT_DESC: 24-inch corrugated metal gravity drainage pipe through the levee, 10 feet below the crown. Flap gate on the waterside (WS) end. Concrete headwall on the landside (LS) end. Concrete U-shaped headwall on the WS end. [Additional Reference(s): DWR Levee Log, 2002. USACE San Joaquin O&M Manual 601.1, 1967, (HLM 26.11)].						
FS Date: 3/25/2014

Concrete headwall on WS toe.

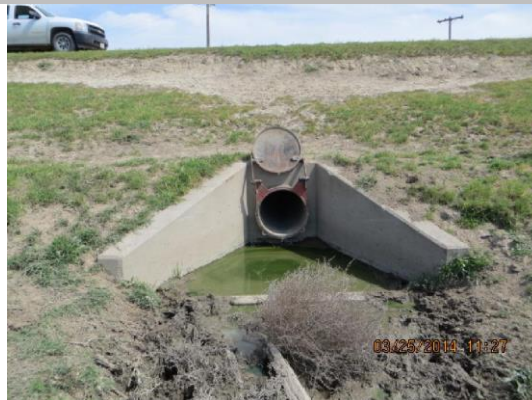
Photo 2 of 3 : UCIP_SP_2020_39627_59340.jpg

Flapgate on Concrete headwall at WS toe.

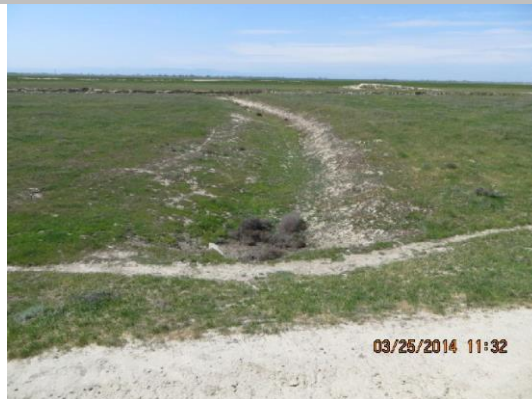
Photo 2 of 3 : UCIP_SP_2020_32804_59346.jpg

Concrete headwall on WS toe.

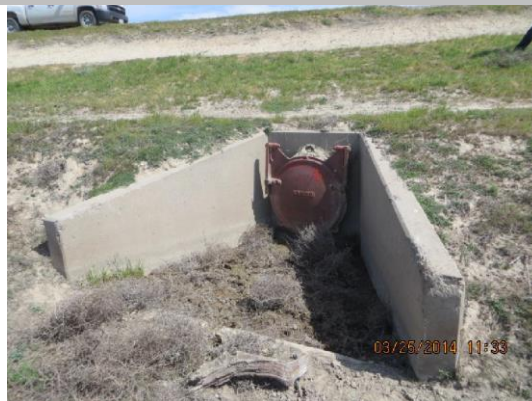
Photo 3 of 3 : UCIP_SP_2020_32804_59345.jpg

Flapgate on Concrete headwall at WS toe.

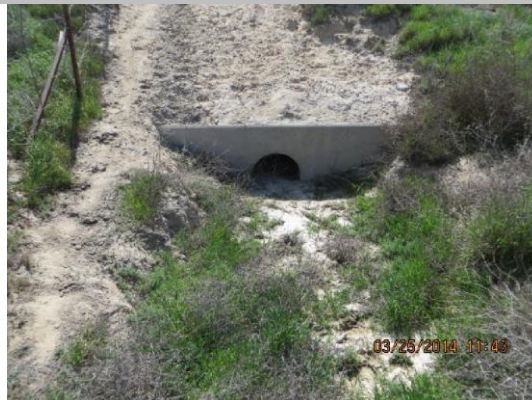
Photo 2 of 3 : UCIP_SP_2020_39628_59349.jpg

Concrete headwall on LS toe.

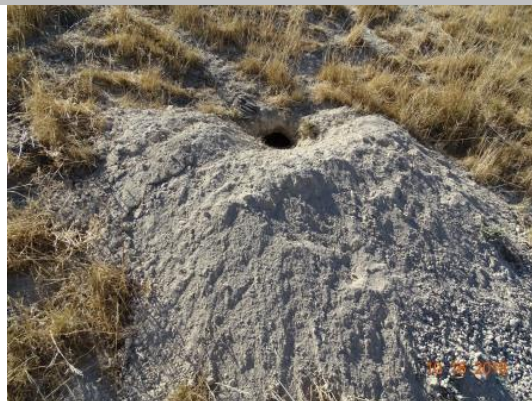
Photo 1 of 1 : SP_2020_NA0010_123_162_20200225_00058.jpg

LM Start	27.00	Rating **	U	Issue No.	162
LM End	27.04	Issue Type +	Ma	Location *	LS
Category	Earthen Levee			GPS Latitude/Longitude	
				Start	End
Item	Animal Control			37.032663 °	37.032659 °
				-120.472907 °	-120.472190 °
DWR ID	DWR_NA0010_05_f_2018_162				
Comment Code					
A3 : No rodents visible, but rodent burrows visible; need to backfill and compact or grout burrows.					
Inspector Comment					
Several rodent burrows with large quantities of material displaced noted in this section.

Rodent burrow noted with large quantity of material displaced. (Fall 2018)

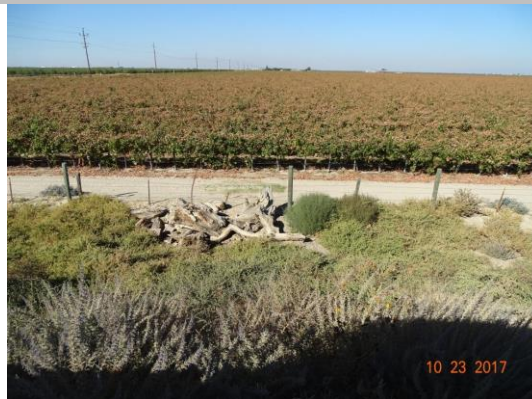
Photo 1 of 1 : SP_2020_NA0010_123_125_20200225_00031.jpg

LM Start	27.01	Rating **	M	Issue No.	125
LM End	27.01	Issue Type +	Ma	Location *	LS
Category	Earthen Levee			GPS Latitude/Longitude	
				Start	End
Item	Encroachments			37.032675 °	37.032675 °
				-120.472841 °	-120.472841 °
DWR ID	DWR_NA0010_05_f _ 2017_125				
Comment Code					
TR : Tree or limb					
Inspector Comment

Looking north at the landside slope.

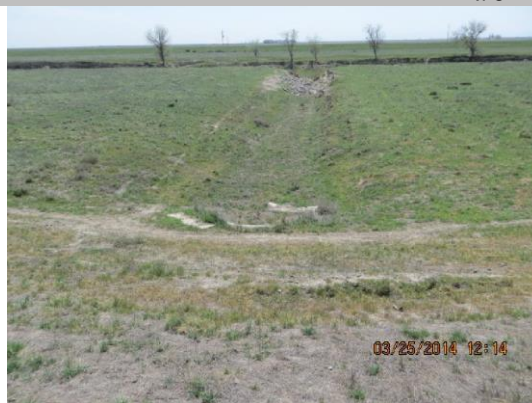
Photo 1 of 3 : UCIP_SP_2020_32823_59382.jpg

LM Start	28.27	Rating **	M	Issue No.	1387
LM End	28.27	Issue Type +	Ma	Location *	
Category	Supplemental			GPS Latitude/Longitude	
				Start	End
Item	DWR UCIP LMA Responsibility			37.032623 °	37.032623 °
				-120.450108 °	-120.450108 °
DWR ID	19750				
Comment Code					
Inspector Comment					
DS_ID:19750 FS_ID:32823 EP_NO: N/A Repair Type: Non-Urgent Crossing Status: Found UCIP Comments: 03/25/2014 Animal Burrowing activity at LS toe may undermine headwall. (DWR UCIP - W. Wylie) FIELD_STRUCT_DESC: 24-inch corrugated metal gravity drainage pipe through the levee, 10.8 feet below the crown. Flap gate on the waterside (WS) end. Concrete headwall on the landside (LS) end. Concrete U-shaped headwall on the WS end. [Additional Reference(s): DWR Levee Log, 2002. USACE San Joaquin O&M Manual 601.1, 1967, (HLM 28.17)]. FS Date: 3/25/2014

Concrete headwall on WS toe.

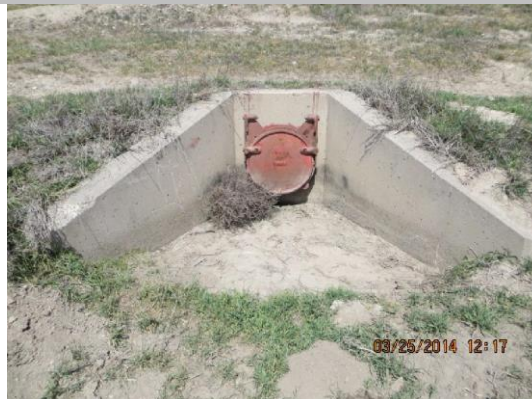
Photo 2 of 3 : UCIP_SP_2020_32823_59383.jpg

Flapgate on Concrete headwall at WS toe.

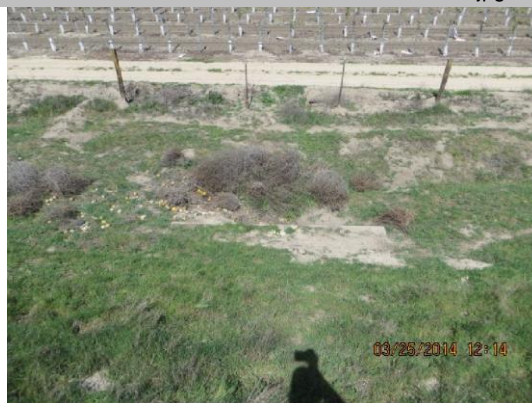
Photo 3 of 3 : UCIP_SP_2020_32823_59381.jpg

Concrete headwall on LS toe.

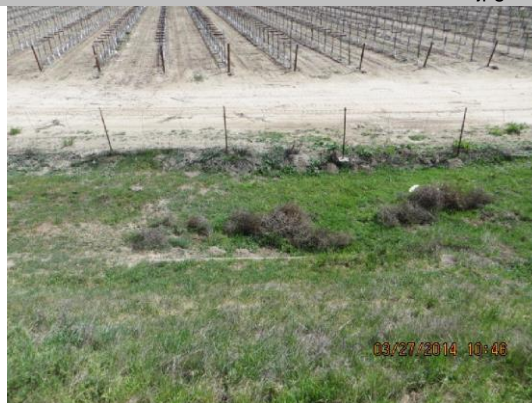
Photo 2 of 3 : UCIP_SP_2020_32832_59419.jpg

Concrete headwall on LS toe.

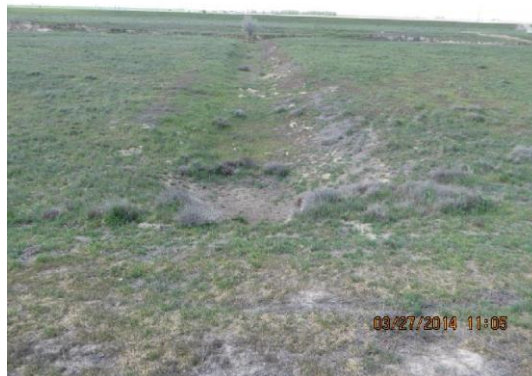
Photo 1 of 3 : UCIP_SP_2020_39884_59414.jpg

DS_ID:19753
FS_ID:39884
EP_NO: N/A
Repair Type: Non-Urgent
Crossing Status: Found
UCIP Comments: 03/27/2014 Dense vegetation limits the inspector's visibility to identify signs of pipe failure (leaks) along the landward slope. Recommend removing vegetation along pipe alignment to conduct proper inspection of structure. Sediment buildup in pipe visible from landward side--recommend contacting owner to clear pipe. (DWR UCIP - W. Wylie)
FIELD_STRUCT_DESC: 36-inch corrugated metal gravity drainage pipe through the levee, 10.2 feet below the crown. Flap gate on the waterside (WS) end. Concrete headwall on the landside (LS) end. Concrete U-shaped headwall on the WS end. [Additional Reference(s): DWR Levee Log, 2002. USACE San Joaquin O&M Manual 601.1, 1967, (HLM 29.49)].
FS Date: 3/27/2014

Concrete headwall on WS toe.

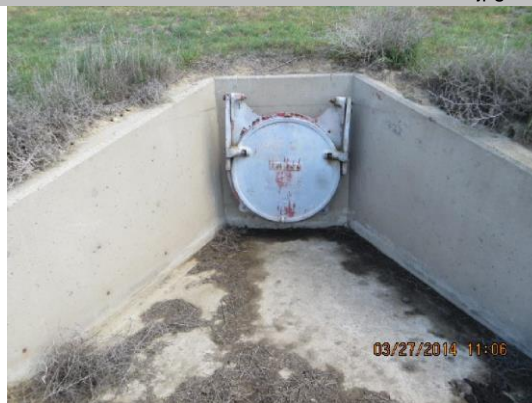
Photo 2 of 3 : UCIP_SP_2020_39884_59413.jpg

Flapgate on Concrete headwall at WS toe.

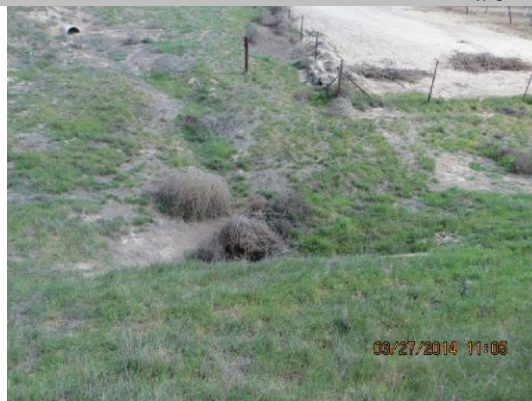
Photo 3 of 3 : UCIP_SP_2020_39884_59415.jpg

Concrete headwall on LS toe.

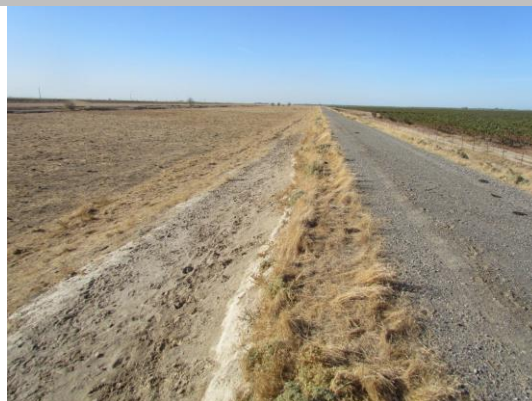
Photo 1 of 1 : SP_2020_NA0010_123_171_20200225_00063.jpg

LM Start	29.68	Rating **	M	Issue No.	171
LM End	29.80	Issue Type +	Ma	Location *	WS
Category	Earthen Levee			GPS Latitude/Longitude	
				Start	End
Item	Animal Control			37.020272 °	37.018712 °
				-120.433737 °	-120.432682 °
DWR ID	DWR_NA0010_05_s_2014_171				
Comment Code					
A2 : Repair the levee slope damaged by livestock and prevent large animal access.					
Inspector Comment					
There is waterside erosion caused by livestock.

Looking north at animal erosion on waterward slope.

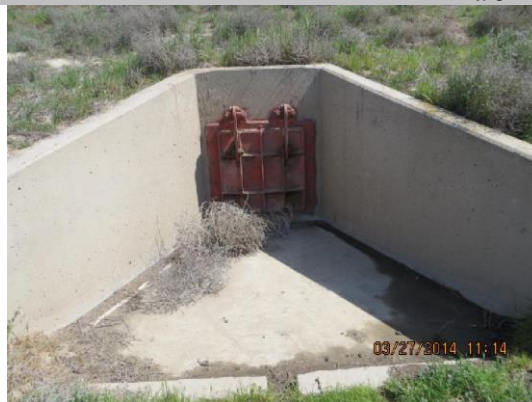
Photo 2 of 3 : UCIP_SP_2020_39631_59426.jpg

Flapgate on Concrete headwall at WS toe.

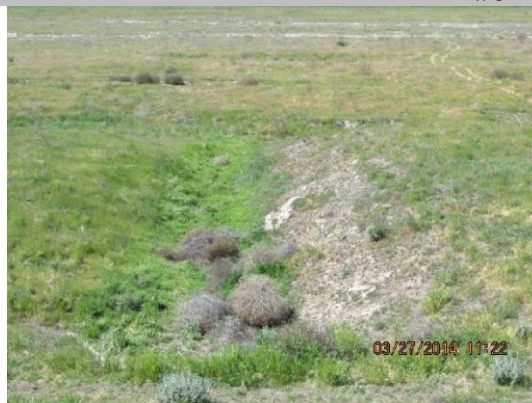
Photo 1 of 3 : UCIP_SP_2020_39632_59430.jpg

Comment Code					
Inspector Comment					
DS_ID:19696 FS_ID:39632 EP_NO: N/A Repair Type: Non-Urgent Crossing Status: Found UCIP Comments: 03/27/2014 Dense vegetation limits the inspector's visibility to identify signs of pipe failure (leaks) along the landward slope. Recommend removing vegetation along pipe alignment to conduct proper inspection of structure. (DWR UCIP - W. Wylie) FIELD_STRUCT_DESC: 30-inch by 30-inch reinforced concrete box gravity drainage culvert through the levee, 13.1 feet below the crown. Flap gate on the waterside (WS) end. Concrete headwall on the landside (LS) end. Concrete U-shaped headwall on the WS end. [Additional Reference(s): DWR Levee Log, 2002. USACE San Joaquin O&M Manual 601.1, 1967, (HLM 30.04)]. FS Date: 3/27/2014

Concrete headwall on WS toe.

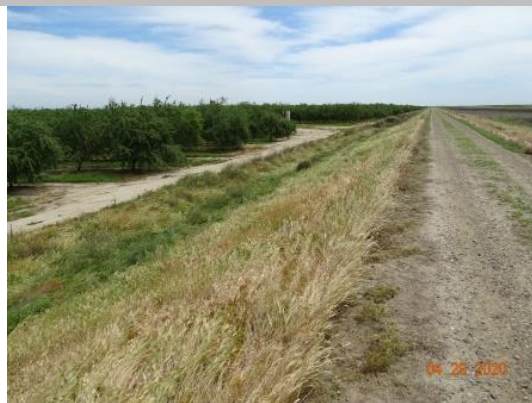
Photo 1 of 1 : SP_2020_NA0010_123_226_20200507_00363.jpg

LM Start	30.45	Rating **	U	Issue No.	226
LM End	31.37	Issue Type +	Ma	Location *	LS
Category	Earthen Levee			GPS Latitude/Longitude	
				Start	End
Item	Vegetation			37.010492 °	37.000923 °
				-120.426907 °	-120.415335 °
DWR ID	DWR_NA0010_05_s_2020_226				
Comment Code					
V1 : Control annual grass and weeds on the levee slopes and easements.					
Inspector Comment

View of the landside slope looking upstream. (Spring 2020)

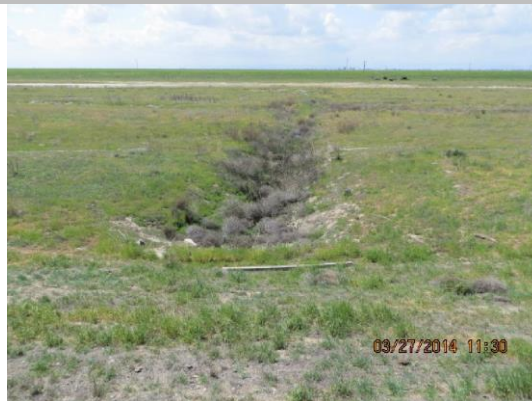
Photo 1 of 3 : UCIP_SP_2020_39633_59435.jpg

Comment Code						
Inspector Comment						
DS_ID:19697 FS_ID:39633 EP_NO: N/A Repair Type: Non-Urgent Crossing Status: Found UCIP Comments: 03/27/2014 Some debris buildup at LS toe. Dense vegetation limits the inspector's visibility to identify signs of pipe failure (leaks) along the landward slope. Recommend removing vegetation along pipe alignment to conduct proper inspection of structure. (DWR UCIP - W. Wylie) FIELD_STRUCT_DESC: 30-inch by 30-inch reinforced concrete box gravity drainage culvert through the levee, 13.3 feet below the crown. Flap gate on the waterside (WS) end. Concrete headwall on the landside (LS) end. Concrete U-shaped headwall on the WS end. [Additional Reference(s): DWR Levee Log, 2002. USACE San Joaquin O&M Manual 601.1, 1967, (HLM 30.96)]. FS Date: 3/27/2014

Concrete headwall on WS toe.

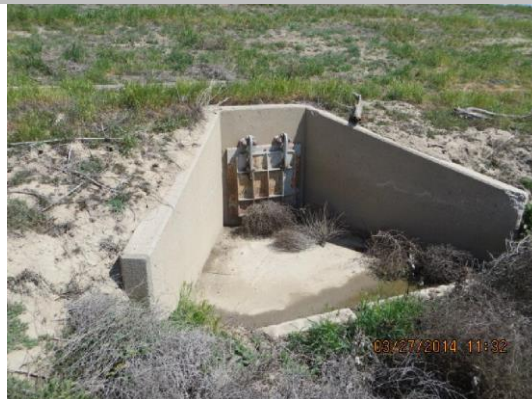
Photo 2 of 3 : UCIP_SP_2020_39633_59436.jpg

Flapgate on Concrete headwall at WS toe.

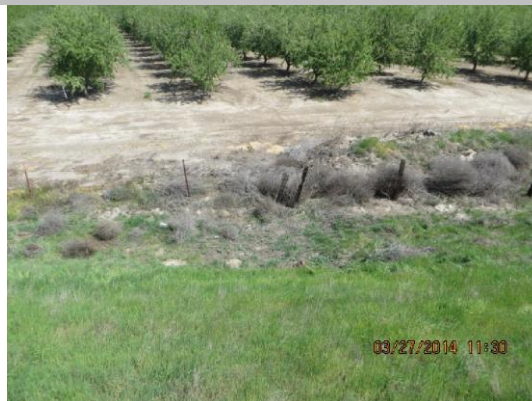
Photo 3 of 3 : UCIP_SP_2020_39633_59434.jpg

Concrete headwall on LS toe.

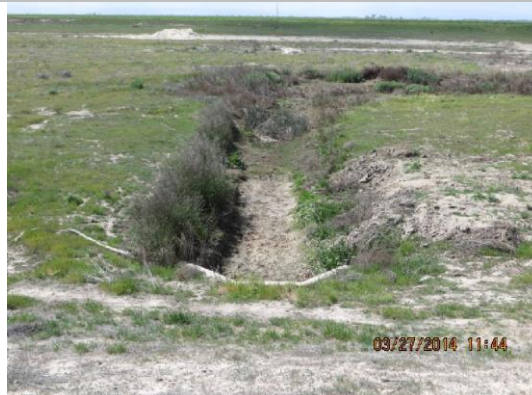
Photo 1 of 3 : UCIP_SP_2020_39643_59439.jpg

Comment Code					
Inspector Comment					
DS_ID:19698 FS_ID:39643 EP_NO: N/A Repair Type: Non-Urgent Crossing Status: Found UCIP Comments: 03/27/2014 Excess vegetation buildup at inlet on LS toe. Dense vegetation limits the inspector's visibility to identify signs of pipe failure (leaks) along the landward slope. Recommend removing vegetation along pipe alignment to conduct proper inspection of structure. (DWR UCIP - W. Wylie) FIELD_STRUCT_DESC: 30-inch by 30-inch reinforced concrete box gravity drainage culvert through the levee, 13.4 feet below the crown. Flap gate on the waterside (WS) end. Concrete headwall on the landside (LS) end. Concrete U-shaped headwall on the WS end. [Additional Reference(s): DWR Levee Log, 2002. USACE San Joaquin O&M Manual 601.1, 1967, (HLM 31.19)]. FS Date: 3/27/2014

Concrete headwall on WS toe.

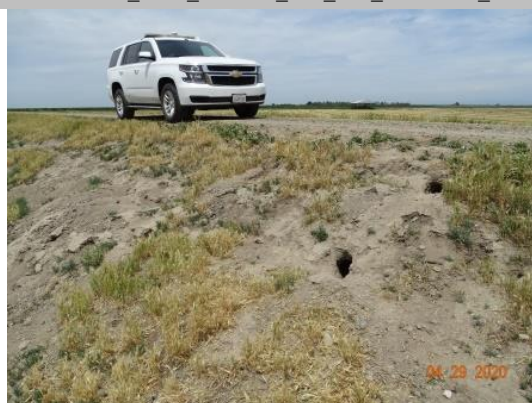
Photo 1 of 1 : SP_2020_NA0010_123_230_20200507_00362.jpg

LM Start	31.66	Rating **	U	Issue No.	230
LM End	31.66	Issue Type +	Ma	Location *	WS
Category	Earthen Levee			GPS Latitude/Longitude	
				Start	End
Item	Animal Control			36.997828 °	36.997828 °
				-120.411920 °	-120.411920 °
DWR ID	DWR_NA0010_05_s_2020_230				
Comment Code					
A3 : No rodents visible, but rodent burrows visible; need to backfill and compact or grout burrows.					
Inspector Comment

Rodent burrows in the waterside slope. (Spring 2020)

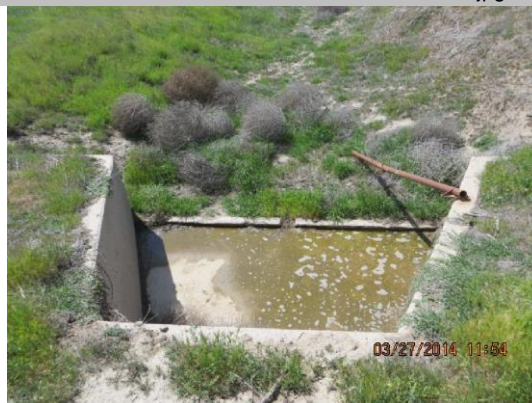
Photo 2 of 3 : UCIP_SP_2020_39644_59442.jpg

Concrete headwall on WS toe.

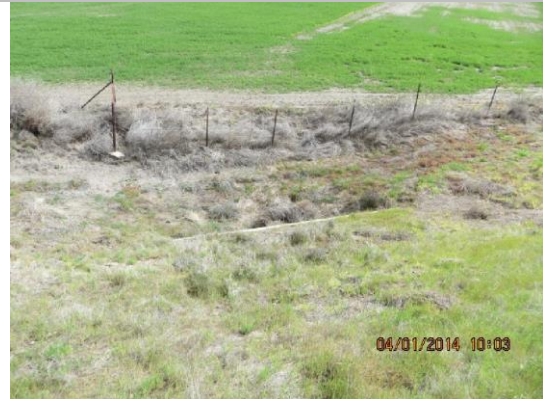
Photo 1 of 3 : UCIP_SP_2020_39646_59690.jpg

Comment Code						
Inspector Comment						
DS_ID:19701						
FS_ID:39646						
EP_NO: N/A						
Repair Type: Non-Urgent						
Crossing Status: Found						
UCIP Comments: 04/01/2014 Some silt buildup inside culvert. (DWR UCIP - W. Wylie)						
FIELD_STRUCT_DESC: 30-inch by 30-inch reinforced concrete box gravity drainage culvert through the levee, 14.2 feet below the crown. Flap gate on the waterside (WS) end. Concrete headwall on the landside (LS) end with flashboard attachment. Concrete U-shaped headwall on the WS end. [Additional Reference(s): DWR Levee Log, 2002. USACE San Joaquin O&M Manual 601.1, 1967, (HLM 32.22)].						
FS Date: 4/1/2014

Concrete headwall at inlet on LS toe.

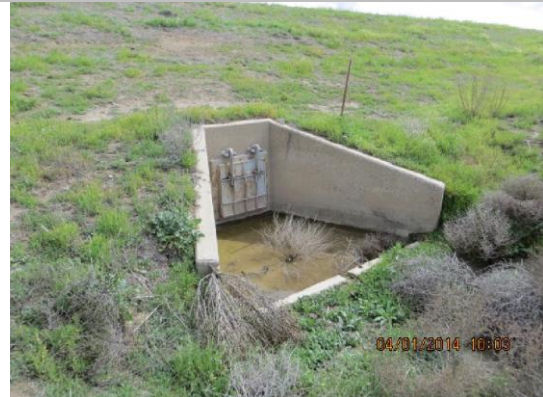
Photo 2 of 3 : UCIP_SP_2020_39646_59688.jpg

Flapgate on Concrete headwall at WS toe.

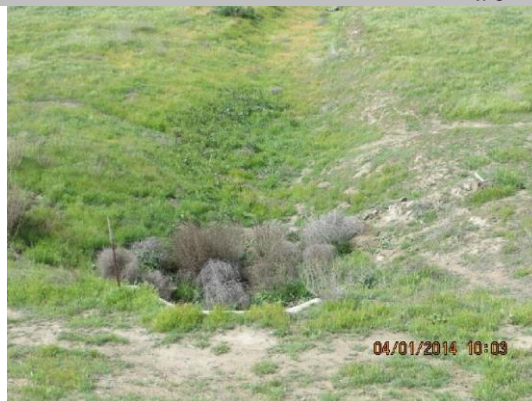
Photo 3 of 3 : UCIP_SP_2020_39646_59689.jpg

Concrete headwall at outlet on WS toe.

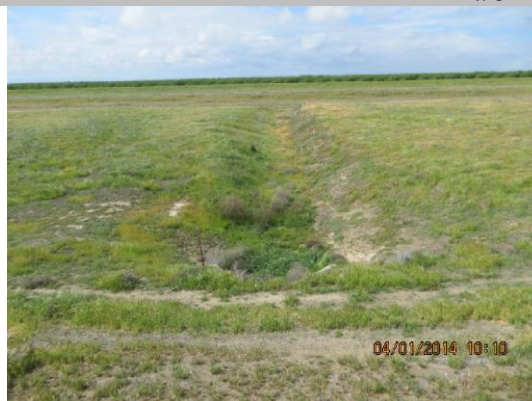
Photo 1 of 3 : UCIP_SP_2020_39647_59697.jpg

DS_ID:19702
 FS_ID:39647
 EP_NO: N/A
 Repair Type: Non-Urgent
 Crossing Status: Found
 UCIP Comments: 04/01/2014 Dense vegetation limits the inspector's visibility to identify signs of pipe failure (leaks) along the landward slope. Recommend removing vegetation along pipe alignment to conduct proper inspection of structure. Debris buildup blocking landward headwall--recommend contacting owner to clear debris. (DWR UCIP - W. Wylie)
 FIELD_STRUCT_DESC: 30-inch by 30-inch reinforced concrete box gravity drainage culvert through the levee, 12.2 feet below the crown. Flap gate on the waterside (WS) end. Concrete headwall on the landside (LS) end. Concrete U-shaped headwall on the WS end. [Additional Reference(s): DWR Levee Log, 2002. USACE San Joaquin O&M Manual 601.1, 1967, (HLM 33.01)].
 FS Date: 4/1/2014

Concrete headwall at WS toe.

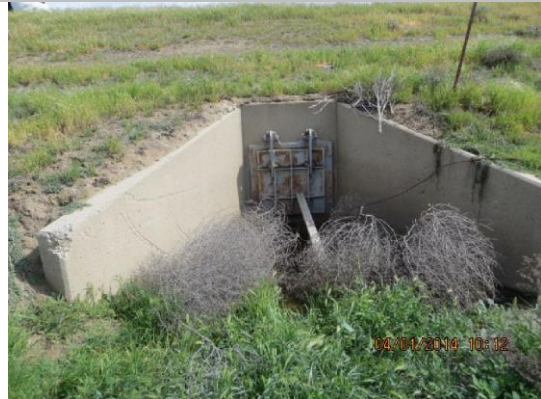
Photo 2 of 3 : UCIP_SP_2020_39647_59699.jpg

Flapgate on Concrete headwall at WS toe.

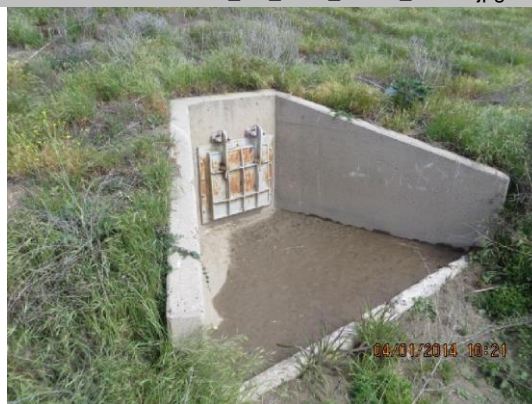
Photo 2 of 3 : UCIP_SP_2020_39648_59700.jpg

Flapgate on Concrete headwall at WS toe.

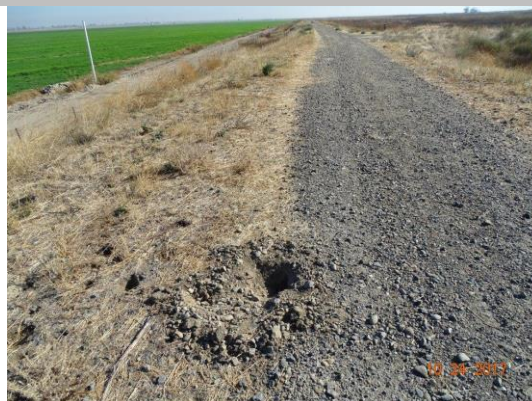
Photo 1 of 1 : SP_2020_NA0010_123_130_20200225_00032.jpg

LM Start	33.82	Rating **	M	Issue No.	130
LM End	33.82	Issue Type +	Ma	Location *	LS
Category	Earthen Levee			GPS Latitude/Longitude	
				Start	End
Item	Animal Control			36.976849 °	36.976849 °
				-120.382393 °	-120.382393 °
DWR ID	DWR_NA0010_05_f_2017_130				
Comment Code					
A3 : No rodents visible, but rodent burrows visible; need to backfill and compact or grout burrows.					
Inspector Comment

Looking east at the landside shoulder.

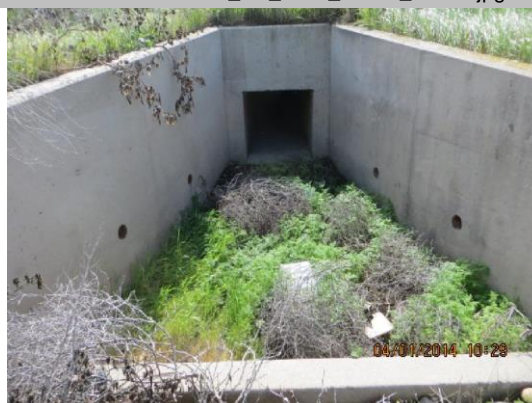
Photo 2 of 3 : UCIP_SP_2020_39649_59704.jpg

Concrete headwall at LS toe.

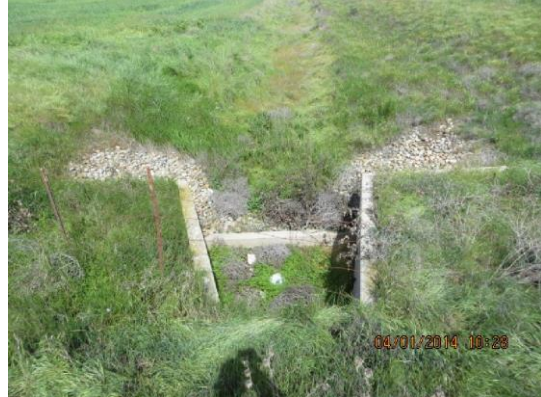
Photo 3 of 3 : UCIP_SP_2020_39649_59705.jpg

Concrete headwall at LS toe.

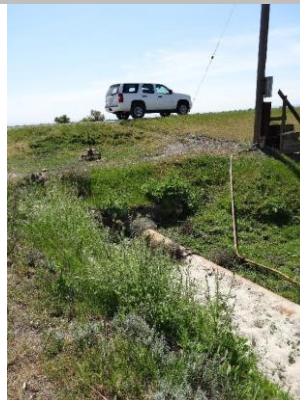
Photo 2 of 3 : UCIP_SP_2020_39463_66343.jpg

View of slope on waterward side.

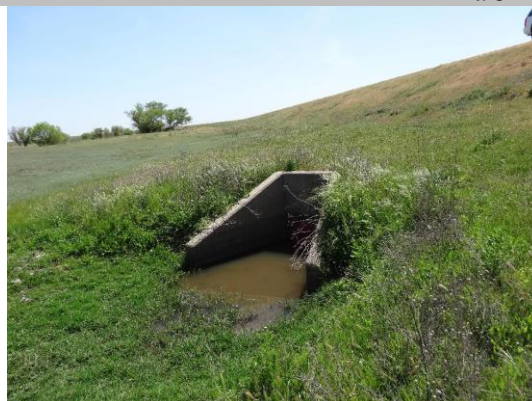
Photo 2 of 3 : UCIP_SP_2020_36565_66345.jpg

Concrete structure located on waterward toe.

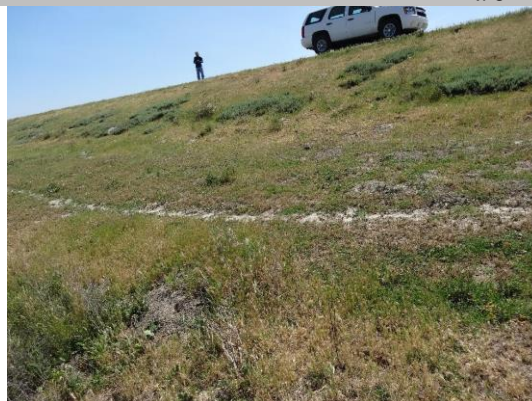
Photo 1 of 3 : UCIP_SP_2020_36566_66348.jpg

LM Start	1.87	Rating **	M	Issue No.	1214	
LM End	1.87	Issue Type +	Ma	Location *		
Category	Supplemental			GPS Latitude/Longitude		
				Start		End
Item	DWR UCIP LMA Responsibility			37.259312 °	37.259312 °	
				-120.802863 °	-120.802863 °	
DWR ID	19817					
Comment Code						
Inspector Comment						
DS_ID:19817						
FS_ID:36566						
EP_NO: N/A						
Repair Type: Non-Urgent						
Crossing Status: Found						
UCIP Comments: 04/18/2014 No access was available to landward side due to fence. Recommend removing some of the vegetation on waterward toe. (DWR UCIP - O. Magana)						
FIELD_STRUCT_DESC: 24-inch corrugated metal gravity drainage pipe through the levee, 13.5 feet below the crown. Flap gate on the waterside (WS) end. Concrete headwall on each end. [Additional Reference(s): DWR Levee Log, 2002. USACE San Joaquin O&M Manual 601.1, 1967, (HLM 1.95)].						
FS Date: 4/18/2014

View of waterward side.

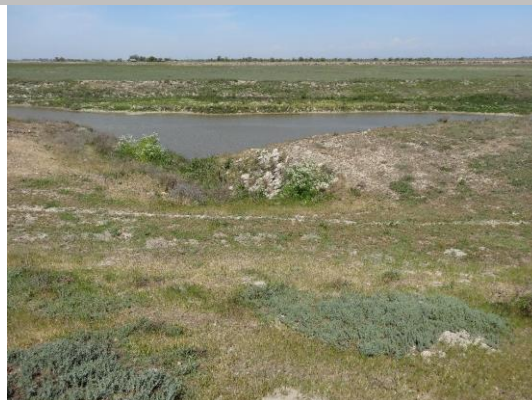
Photo 2 of 3 : UCIP_SP_2020_36566_66350.jpg

View of waterward side.

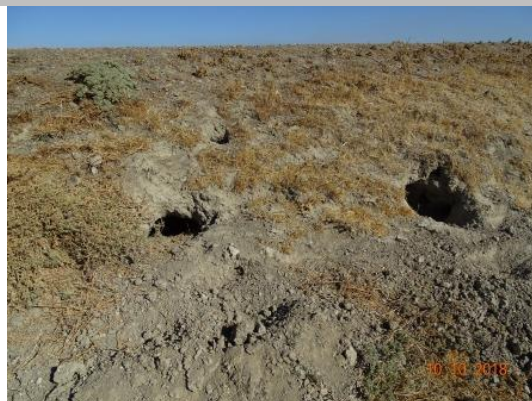
Photo 1 of 1 : SP_2020_NA0010_124_92_20200225_00038.jpg

LM Start	2.42	Rating **	U	Issue No.	92
LM End	2.42	Issue Type +	Ma	Location *	LS
Category	Earthen Levee			GPS Latitude/Longitude	
				Start	End
Item	Animal Control			37.254519 °	37.254519 °
				-120.795141 °	-120.795141 °
DWR ID	DWR_NA0010_06_f_2018_92				
Comment Code					
A3 : No rodents visible, but rodent burrows visible; need to backfill and compact or grout burrows.					
Inspector Comment

View of large rodent holes in landside slope. (Fall 2018)

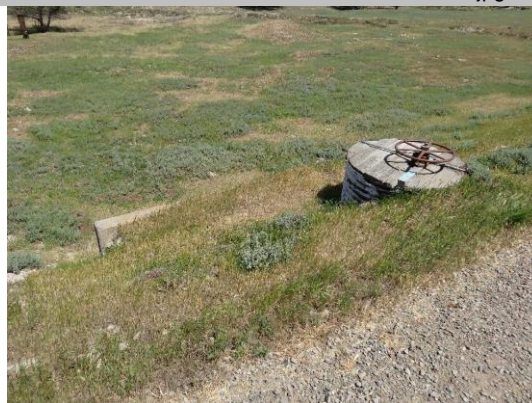
Photo 2 of 3 : UCIP_SP_2020_39464_66357.jpg

View of waterward side.

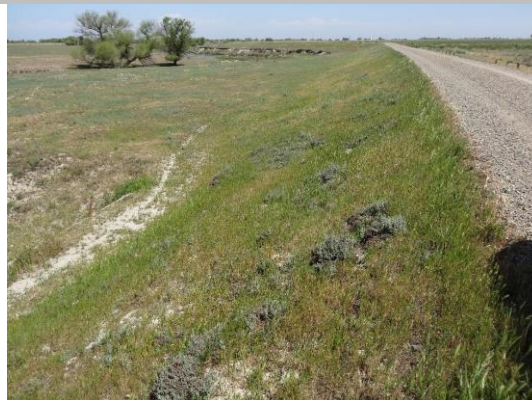
Photo 2 of 3 : UCIP_SP_2020_36568_66360.jpg

View of waterward side.

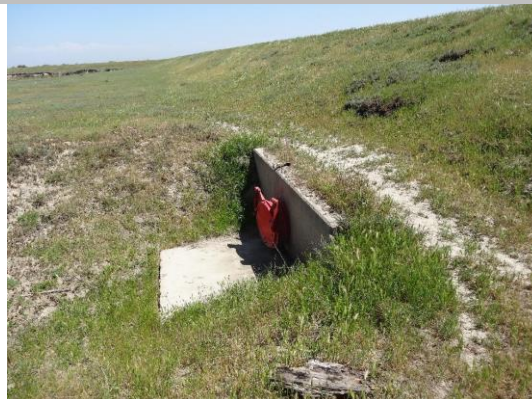
Photo 3 of 3 : UCIP_SP_2020_36568_66359.jpg

View of concrete headwall, flap gate, and concrete apron located on waterward side.

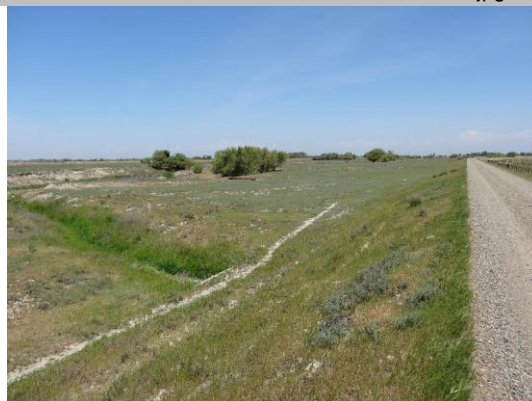
Photo 1 of 3 : UCIP_SP_2020_36569_66369.jpg

DS_ID:19820
 FS_ID:36569
 EP_NO: N/A
 Repair Type: Non-Urgent
 Crossing Status: Found
 UCIP Comments: 04/18/2014 Dense vegetation limits the inspector's visibility to identify signs of pipe condition on landward toe--headwall blocked by dense vegetation. Recommend removing vegetation from landward toe. (DWR UCIP - O. Magana)
 FIELD_STRUCT_DESC: 24-inch corrugated metal gravity drainage pipe through the levee, 10.5 feet below the crown. Flap gate on the waterside (WS) end. Concrete headwall on each end. [Additional Reference(s): DWR Levee Log, 2002. USACE San Joaquin O&M Manual 601.1, 1967, (HLM 2.85)].
 FS Date: 4/18/2014

View of waterward side.

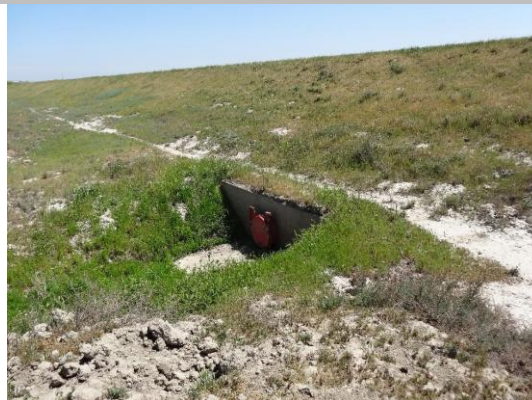
Photo 2 of 3 : UCIP_SP_2020_36583_66380.jpg

Flap gate and concrete headwall visible on waterward side.

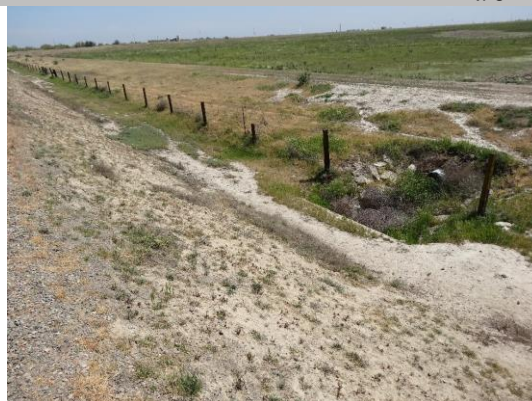
Photo 3 of 3 : UCIP_SP_2020_36583_66383.jpg

View of landward side.

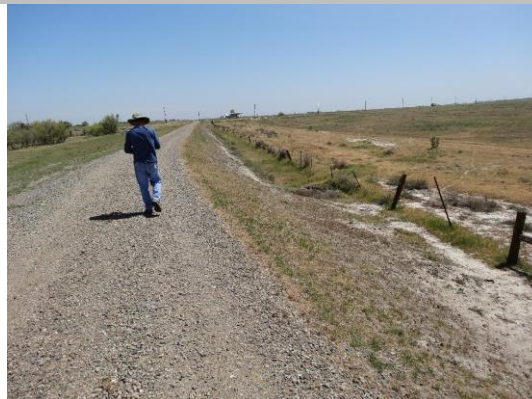
Photo 1 of 3 : UCIP_SP_2020_36584_66384.jpg

Comment Code						
Inspector Comment						
DS_ID:19822 FS_ID:36584 EP_NO: N/A Repair Type: Non-Urgent Crossing Status: Found UCIP Comments: 04/18/2014 Dense vegetation limits the inspector's visibility to identify signs of pipe condition on waterward slope and landward toe (headwall blocked by dense vegetation). Recommend removing vegetation from landward toe. (DWR UCIP - O. Magana) FIELD_STRUCT_DESC: 24-inch corrugated metal gravity drainage pipe through the levee, 10.4 feet below the crown. Flap gate on the waterside (WS) end. Concrete headwall on each end. [Additional Reference(s): DWR Levee Log, 2002. USACE San Joaquin O&M Manual 601.1, 1967, (HLM 3.29)]. FS Date: 4/18/2014

Overview of levee crown and landward side.

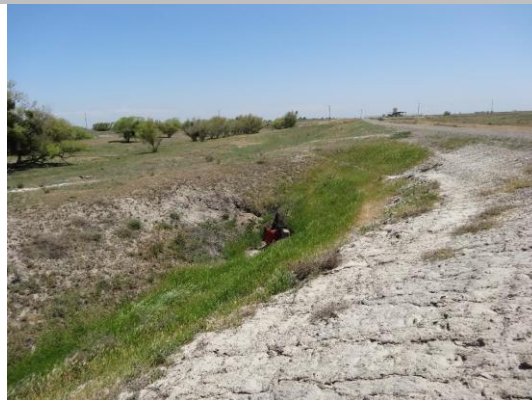
Photo 2 of 3 : UCIP_SP_2020_36584_66386.jpg

View of waterward side.

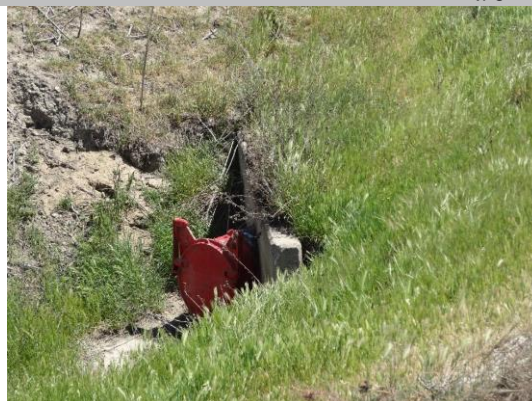
Photo 3 of 3 : UCIP_SP_2020_36584_66385.jpg

Crossing goes through the levee at an angle. Flap gate visible on waterward side.

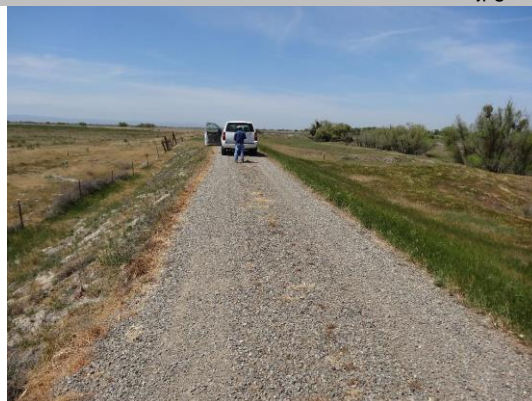
Photo 1 of 3 : UCIP_SP_2020_36585_66389.jpg

DS_ID:19823
FS_ID:36585
EP_NO: N/A
Repair Type: Non-Urgent
Crossing Status: Found
UCIP Comments: 04/18/2014 Alignment of crossing unknown--altered crossing. No headwall found on landward side only siphon breaker found a short distance from landward toe. Tall grass observed on waterward slope and some burrow activity also noticed. Need to contact owner to determine alignment of crossing and status of crossing. (DWR UCIP - O. Magana)
FIELD_STRUCT_DESC: 36-inch corrugated metal gravity drainage pipe through the levee, 15.7 feet below the crown. Flap gate on the waterside (WS) end. Concrete U-shaped headwall on each end. Bench mark (BM) stamped 9770-152 on top of the WS headwall. [Additional Reference(s): DWR Levee Log, 2002. USACE San Joaquin O&M Manual 601.1, 1967, (HLM 3.43)].
FS Date: 4/18/2014

Overview of levee crown at crossing.

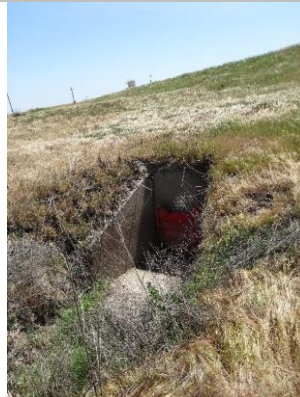
Photo 2 of 3 : UCIP_SP_2020_36585_66390.jpg

Flap gate and concrete headwall visible on waterward side.

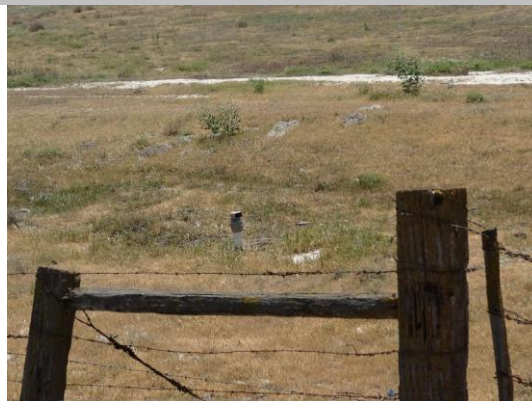
Photo 3 of 3 : UCIP_SP_2020_36585_66391.jpg

View of landward side. No signs of concrete headwall only siphon breaker visible on landward side.

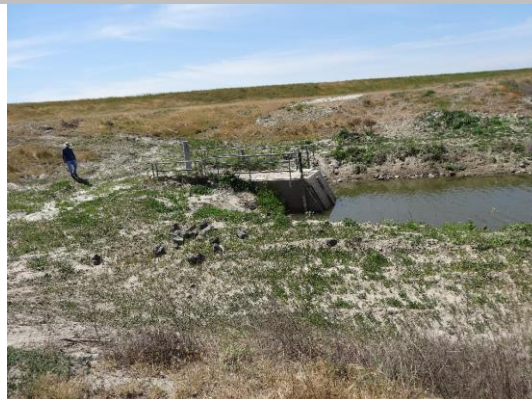
Photo 1 of 3 : UCIP_SP_2020_39482_71643.jpg

Comment Code						
Inspector Comment						
DS_ID:19824 FS_ID:39482 EP_NO: 6965 Repair Type: Non-Urgent Crossing Status: Indicator Found UCIP Comments: 04/18/2014 Description of structure does not match. Need to contact owner. Current description includes concrete platform, trash screen, and gage reading on waterward side. Metal box located on waterward shoulder. Large plant facility locate on landward side. (DWR UCIP - O. Magana) FIELD_STRUCT_DESC: 16-inch coated steel irrigation discharge pipe through the levee, 7.4 feet below the crown. Corrugated metal cutoff wall around the pipe in the center of the levee. Pump on the waterside (WS) with a timber platform on the berm for support. Siphon breaker on the apex of the pipe on the landside (LS) shoulder. Pipe exposed on both slopes. (Plans to place a 20-inch irrigation pipe through the levee authorized under Permit No. 6965, 1971 - Scarborough, Robinson, and Associates). [Additional Reference(s): DWR Levee Log, 2002]. FS Date: 4/10/2014

View of structure located on waterward side.

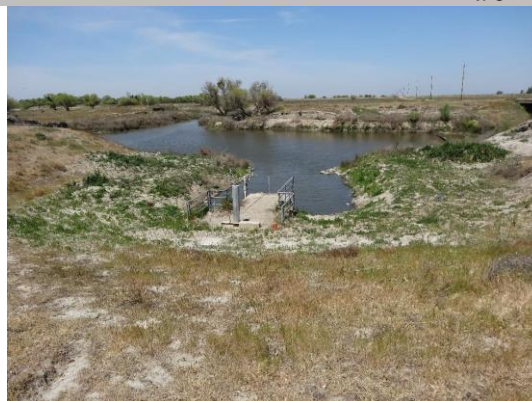
Photo 2 of 3 : UCIP_SP_2020_39482_71644.jpg

View of waterward side.

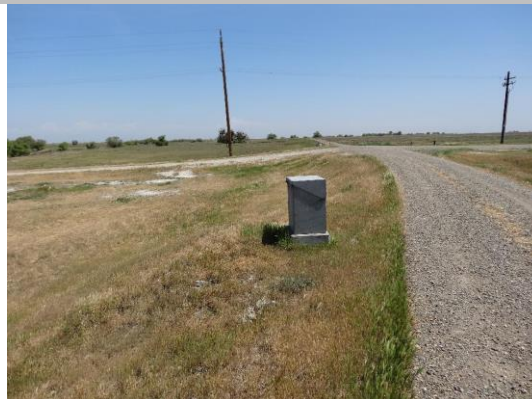
Photo 3 of 3 : UCIP_SP_2020_39482_71642.jpg

Metal box located on waterward shoulder.

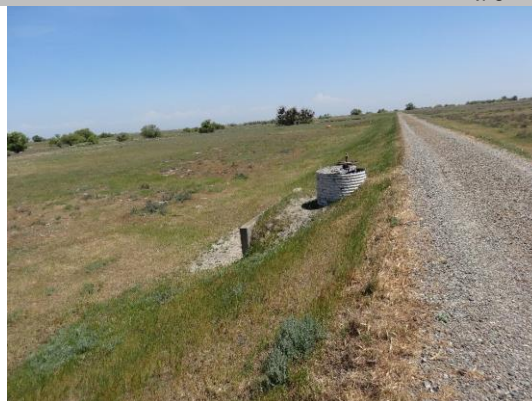
Photo 1 of 3 : UCIP_SP_2020_39465_66394.jpg

DS_ID:19825
 FS_ID:39465
 EP_NO: N/A
 Repair Type: Non-Urgent
 Crossing Status: Found
 UCIP Comments: 04/18/2014 Sediment buildup inside pipe visible from landward side. Excess soil is also present on landward toe partially blocking concrete headwall and inlet. Recommend removing soil from landward toe and clear buildup inside. (DWR UCIP - O. Magana)
 FIELD_STRUCT_DESC: 36-inch corrugated metal gravity drainage pipe through the levee, 6.8 feet below the crown. Slide gate in a 48-inch corrugated metal pipe (CMP) riser on the waterside (WS) slope. Concrete headwall on each end. Pipe connects to a 30-inch steel drainage pipe on the WS. Drainage pipe extends to the pump on the WS on a support platform in the channel. (Extension drainage pipe and pump installed under Permit No. 12527, 1979 - Joseph Gallo).
 [Additional Reference(s): DWR Levee Log, 2002. USACE San Joaquin O&M Manual 601.1, 1967, (HLM 3.54)].

View of waterward side--cmp riser and concrete headwall visible.

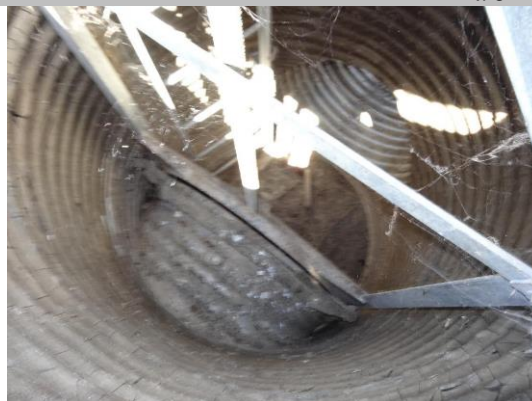
Photo 2 of 3 : UCIP_SP_2020_39465_66395.jpg

Inside view of cmp riser located on waterward slope.

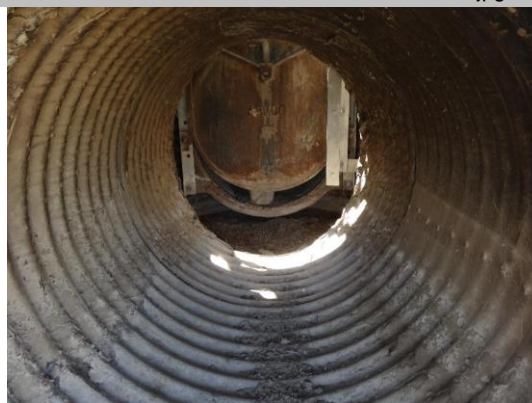
Photo 3 of 3 : UCIP_SP_2020_39465_66397.jpg

Inside view of pipe from waterward side.

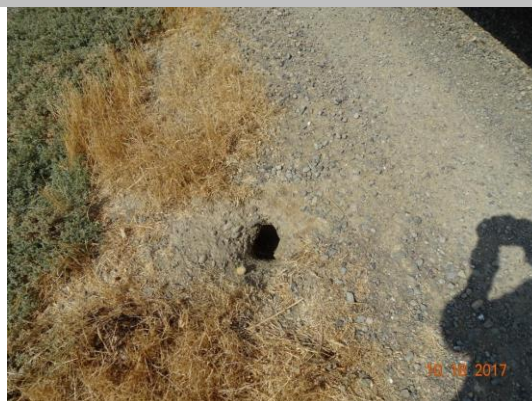
Photo 1 of 1 : SP_2020_NA0010_124_67_20200225_00015.jpg

LM Start	3.49	Rating **	M	Issue No.	67
LM End	3.49	Issue Type +	Ma	Location *	LS
Category	Earthen Levee			GPS Latitude/Longitude	
				Start	End
Item	Animal Control			37.251602 °	37.251602 °
				-120.778118 °	-120.778118 °
DWR ID	DWR_NA0010_06_f_2017_67				
Comment Code					
A3 : No rodents visible, but rodent burrows visible; need to backfill and compact or grout burrows.					
Inspector Comment

Looking east at the landside slope.

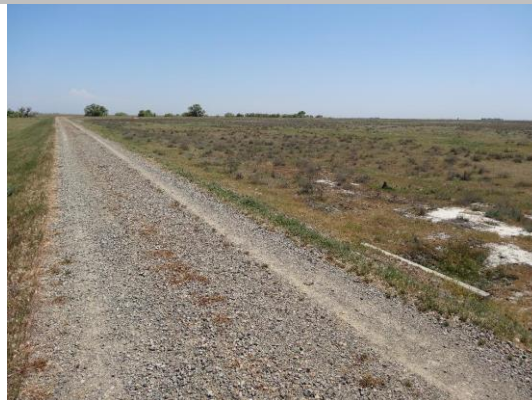
Photo 2 of 3 : UCIP_SP_2020_39466_66412.jpg

LM Start	3.69	Rating **	M	Issue No.	1223	
LM End	3.69	Issue Type +	Ma	Location *		
Category	Supplemental			GPS Latitude/Longitude		
				Start		End
Item	DWR UCIP LMA Responsibility			37.251199 °		37.251199 °
				-120.774474 °		-120.774474 °
DWR ID	19826					
Comment Code						
Inspector Comment						
DS_ID:19826 FS_ID:39466 EP_NO: N/A Repair Type: Non-Urgent Crossing Status: Found UCIP Comments: 04/18/2014 Sediment buildup inside crossing and is visible from landward side. Recommend clearing sediment buildup inside pipe and check wall integrity to determine condition. (DWR UCIP - O. Magana) FIELD_STRUCT_DESC: 24-inch corrugated metal gravity drainage pipe through the levee, 7 feet below the crown. Flap gate on the waterside (WS) end. Concrete headwall on each end. [Additional Reference(s): DWR Levee Log, 2002. USACE San Joaquin O&M Manual 601.1, 1967, (HLM 3.77)]. FS Date: 4/18/2014

View of landward side.

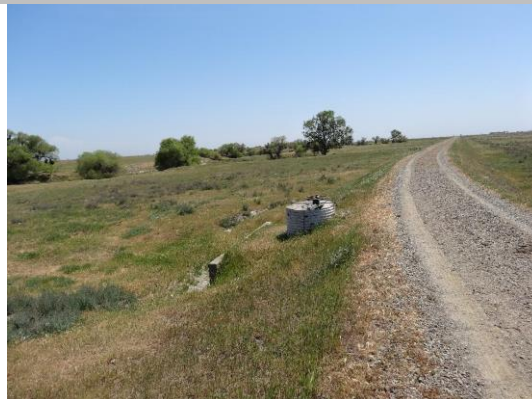
Photo 1 of 3 : UCIP_SP_2020_39467_66407.jpg

Comment Code						
Inspector Comment						
DS_ID:19827 FS_ID:39467 EP_NO: N/A Repair Type: Non-Urgent Crossing Status: Found UCIP Comments: 04/18/2014 Sediment buildup inside crossing and is visible from landward side. Recommend clearing sediment buildup inside pipe and check wall integrity to determine condition. (DWR UCIP - O. Magana) FIELD_STRUCT_DESC: 36-inch corrugated metal gravity drainage pipe through the levee, 6.7 feet below the crown. Slide gate in a 48-inch corrugated metal pipe (CMP) riser on the waterside (WS) slope. [Additional Reference(s): DWR Levee Log, 2002. USACE San Joaquin O&M Manual 601.1, 1967, (HLM 3.97)]. FS Date: 4/18/2014

View of waterward side.

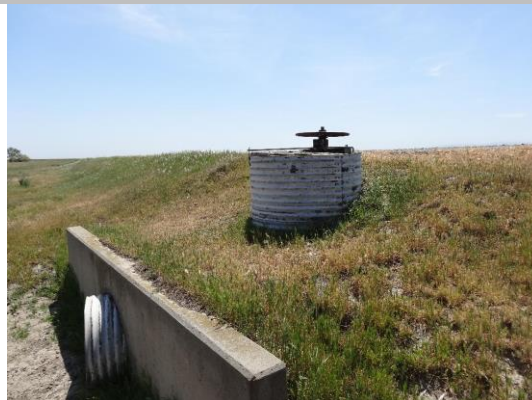
Photo 2 of 3 : UCIP_SP_2020_39467_66406.jpg

Slide gate inside CMP riser visible on waterward slope.

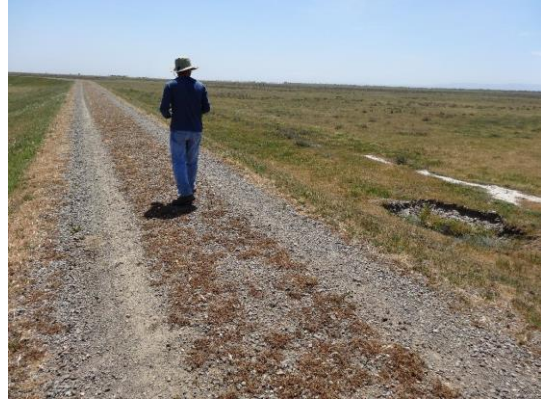
Photo 2 of 3 : UCIP_SP_2020_36606_66417.jpg

Overview of levee crown at crossing.

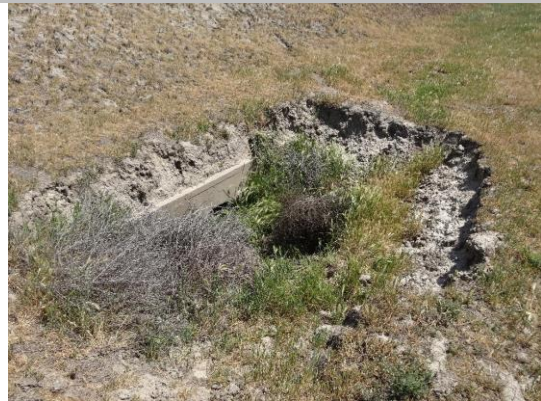
Photo 3 of 3 : UCIP_SP_2020_36606_66416.jpg

Concrete headwall visible on landward side.

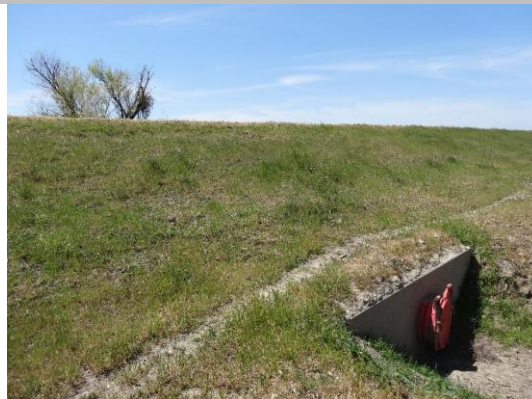
Photo 1 of 2 : UCIP_SP_2020_36607_66422.jpg

Comment Code						
Inspector Comment						
DS_ID:19829 FS_ID:36607 EP_NO: N/A Repair Type: Non-Urgent Crossing Status: Found UCIP Comments: 04/18/2014 Dense vegetation limits the inspector's visibility to identify signs of pipe condition on landward toe--headwall blocked by dense vegetation. Recommend removing vegetation from landward toe. (DWR UCIP - O. Magana) FIELD_STRUCT_DESC: 24-inch corrugated metal gravity drainage pipe through the levee, 11.3 feet below the crown. Flap gate on the waterside (WS) end. Concrete headwall on each end. [Additional Reference(s): DWR Levee Log, 2002. USACE San Joaquin O&M Manual 601.1, 1967, (HLM 4.41)]. FS Date: 4/18/2014

View of waterward side--concrete headwall and flap gate visible.

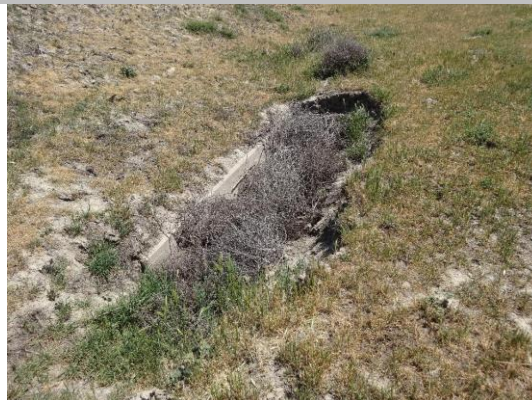
Photo 2 of 2 : UCIP_SP_2020_36607_66421.jpg

View of landward side--concrete headwall visible through dense vegetation.

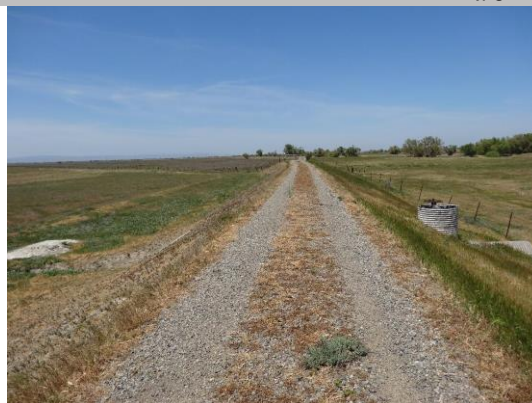
Photo 1 of 3 : UCIP_SP_2020_39468_66425.jpg

Comment Code					
Inspector Comment					
DS_ID:19830 FS_ID:39468 EP_NO: N/A Repair Type: Non-Urgent Crossing Status: Found UCIP Comments: 04/18/2014 Sediment buildup inside crossing visible from landward side. Recommend clearing sediment buildup inside pipe and check wall integrity to determine condition. (DWR UCIP - O. Magana) FIELD_STRUCT_DESC: 36-inch corrugated metal gravity drainage pipe through the levee, 6.9 feet below the crown. Slide gate in a 48-inch corrugated metal pipe (CMP) riser on the waterside (WS) slope. Concrete headwall on the landside (LS) end. Concrete saddle and apron on the WS end. [Additional Reference(s): DWR Levee Log, 2002. USACE San Joaquin O&M Manual 601.1, 1967, (HLM 4.70)]. FS Date: 4/18/2014

Overview of levee crown at crossing.
